September 15, 2016 Volume 6, Issue 2

## **Cedar Bluff District Fisheries**

**Kansas Department of Wildlife, Parks, and Tourism Fisheries Division**

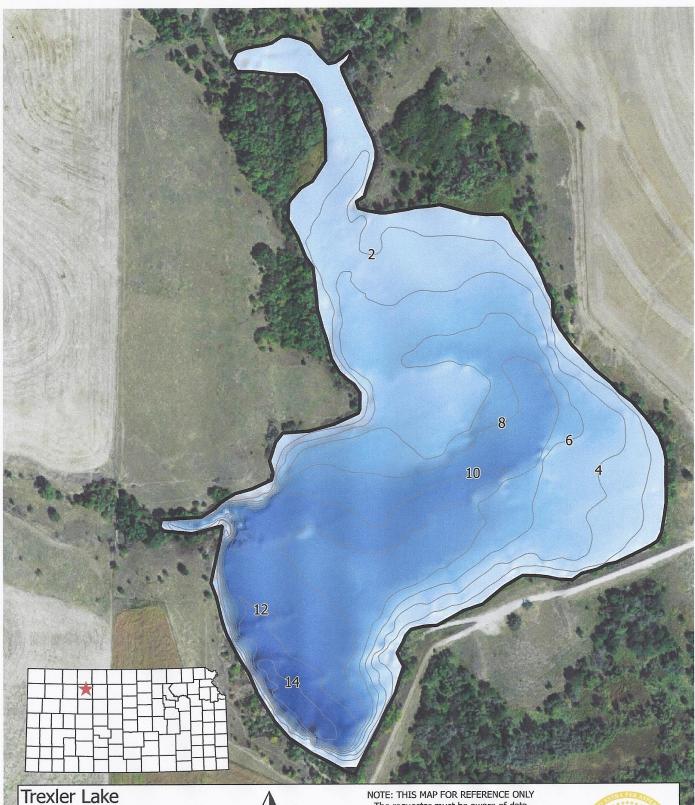
Trexler Lake 39.4241N, 99.8507W Area: 42 acres

Volume: 258 acre-feet Mean depth: 6.1 feet Maximum depth: 16.7 feet N

Data collected July, 2014

In the Cedar Bluff District; Graham Co.-Antelope Lake, Scott State Fishing Lake, Sheridan State Fishing Lake, and Graham Co. FISH-Trexler Lake have been mapped. Each map is included on it's own full page following in this newsletter so the subscriber can print out their own fishing map. Each bathymetric map conveys a good overall look at the bottom contours of each lake, revealing fish attracting structures so anglers can locate and catch more fish.
