Cedar Bluff District Fisheries

Kansas Department of Wildlife, Parks, and Tourism Fisheries Division
Newsletter Date: May 2020 Volume 10, Issue 1

Colby-Villa High Pond Renovation Nears Completion

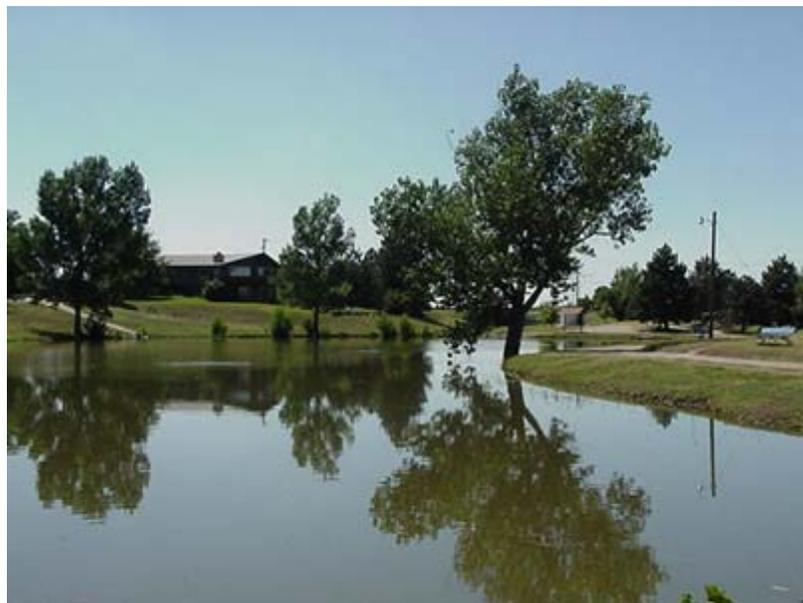
Villa High Pond prior to renovation

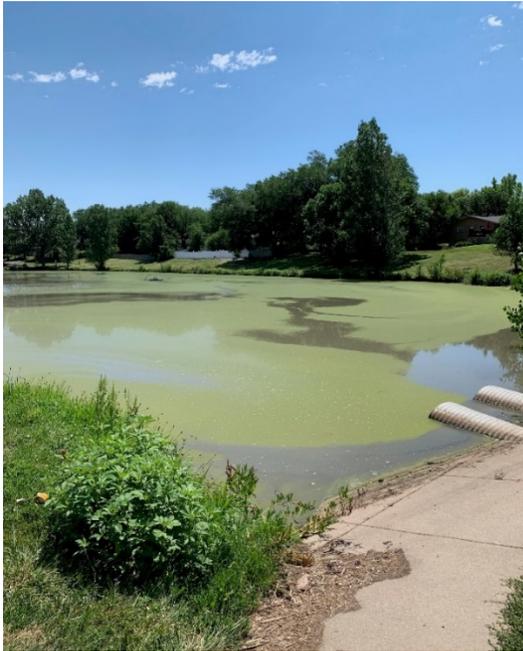
Excessive algae bloom at Villa High

Excessive algae blooms have been relatively frequent and often led to partial fish kills at Villa High. The fish kills tended to kill desirable sportfish like largemouth bass, bluegill, and channel catfish, but

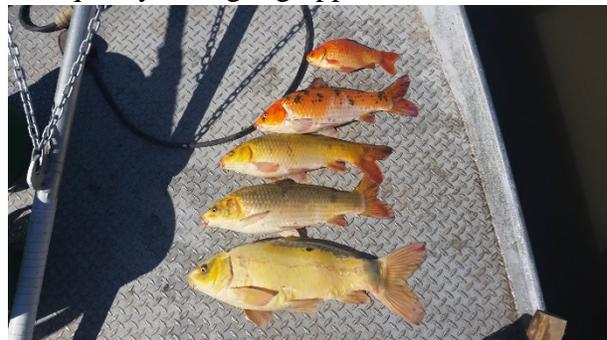
were not severe enough to eliminate fish species capable of tolerating low dissolved oxygen concentrations such as black bullheads, green sunfish, fathead minnows, and golden shiners. Further, unauthorized public stocking of tolerant aquarium fish species such as goldfish and koi carp resulted in a hodge-podge fishery that limited the quality of angling opportunities available.

Example of goldfish and koi carp from Villa High

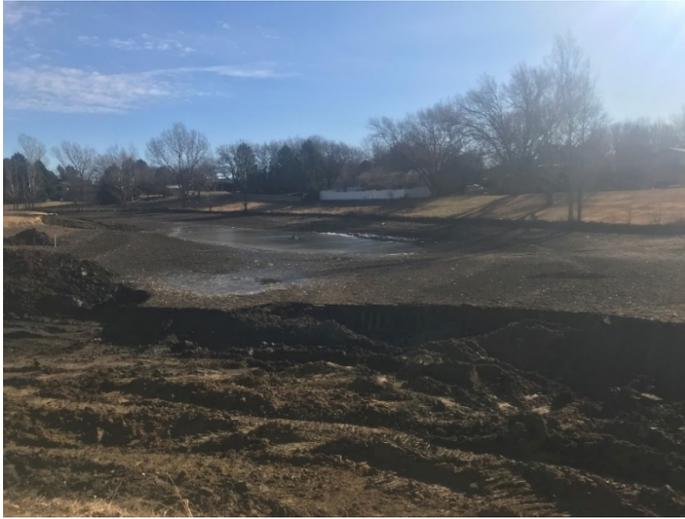
High sedimentation rates from construction of adjacent homes, cultivation of agricultural fields, and other dirt work over the years decreased the volume and depth of Villa High resulting in a pond with a maximum depth of less than 6 feet and average depth of approximately 2.5 feet. Lack of pond volume simply limited the physical space available to fish. Further, nutrients can often be sequestered from pond water if the nutrients become buried by sediment and locked in an anaerobic state. However, given the shallow pond depth,

Early stages of excavation at Villa High, note sediment thickness and overall shallowness of basin

Once the pond was almost completely dewatered excavating began using track hoes to remove sediment and load it in dump trucks to be hauled off site and disposed of in an abandoned city wastewater lagoon. Sediment removal was initiated mid-December 2019 and continued until February 2020. Sediment thickness generally varied from 3 to 8 feet and a total of approximately 12,500 cubic yards were removed. Once sediment removal was complete the pond now has a maximum depth of 12 feet and average depth of 7 feet at full pool.

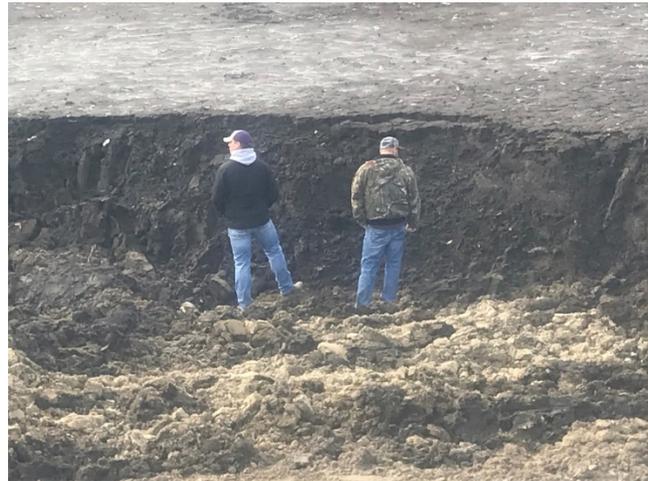
Another example of sediment thickness, note the light-colored original bottom material

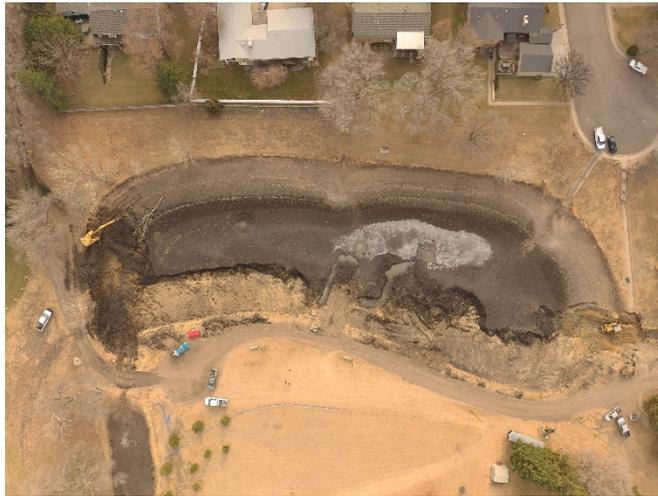
Aerial view of Villa High early excavation on December 23, 2019. Note dark sediment and light-colored original pond basin

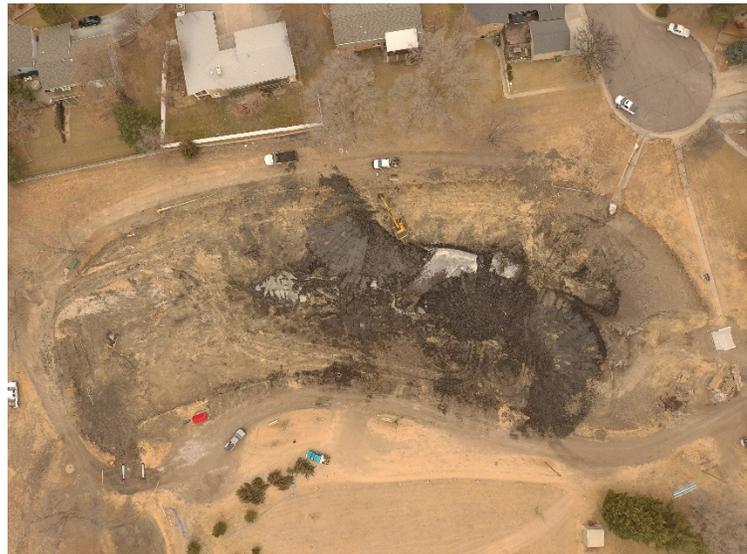
Aerial view of sediment removal progress on January 21, 2020

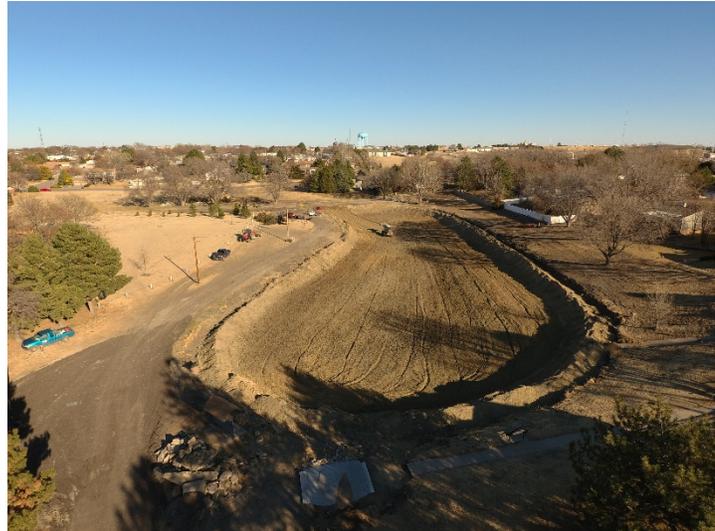
City and county staff drying and stockpiling bottom material prior to basing sealing

material would be available to form the successive layers. It was decided that as bottom material was ripped, disked and dried, it would be pushed up from the basin bottom and stockpiled in a concentric ring around the shoreline. The final seal configuration consisted of two treated and compacted six-inch layers over the deeper parts of the basin while the 10 to 15-yard-wide ring around the shoreline was a single layer treated with soda ash, compacted, and was overlaid with untreated material to protect the seal.

City and County crews, with oversight from EBH engineering and a private consultant with experience in the technique, sealed the basin over the course of one day in early-March 2020. Once the bottom material that was to become the first seal layer was exposed it was disked and let set until the proper moisture level was achieved. Soda ash was spread at a rate of 14 lbs. per 100 square feet of pond bottom using fertilizer spreaders. Once applied, the soda ash was then disked into the pond bottom to ensure uniform contact with bottom material particles. Once the soda ash was incorporated, the treated bottom material layer was compacted using sheep's foot equipment.

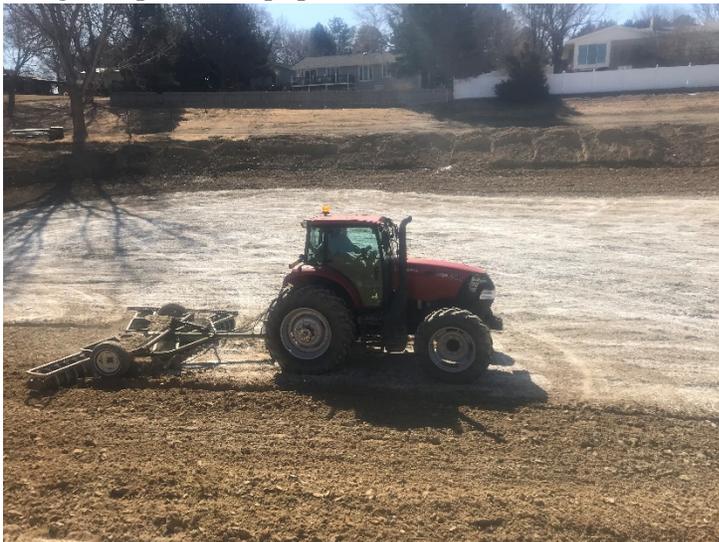
County staff diskings white soda ash into bottom material

Once the first layer was complete, stockpiled bottom material was moved down and spread over the first treated layer using motor graders, soda ash applied, and compacted as above to form the second layer. To finish, all remaining stockpiled material was moved down the sides of the basin exposing the untreated ring around the shoreline. This ring was disked, soda ash applied, and packed as above. To eliminate a seam between the two sealed areas the edges of the respective areas were overlapped. Finally, the remaining untreated, stockpiled bottom material was moved up to create a uniform

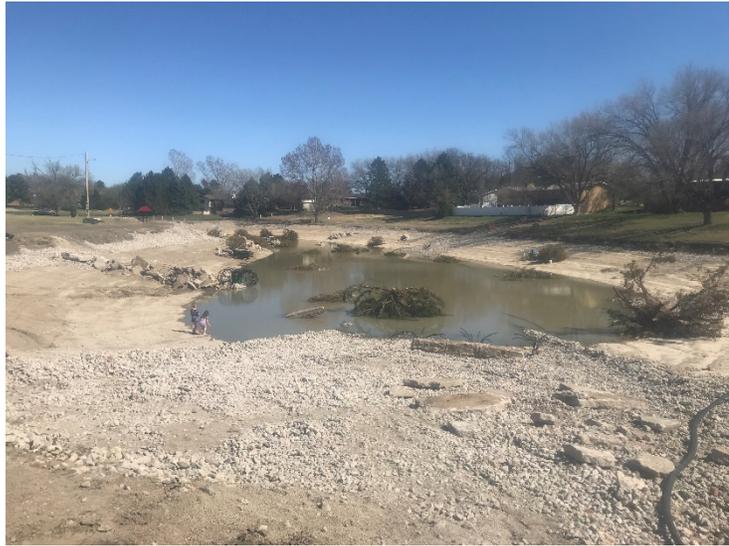
Villa High beginning to impound water, note fish habitat structures and basin armoring

Once the seal was installed, efforts turned to protecting the seal from wave action and flowing water erosion, and fish habitat structures were installed. Large slabs, and smaller crushed, concrete chunks were placed to armor the basin at points of inflow and in a band around the entire upper basin to prevent erosion. A wide range of materials including broken concrete, whole cedar trees, and artificial structures were constructed and installed at various water depths. Prior to renovation, fish habitat availability in Villa High was almost non-existent, but with all the work and creativity of City staff, fish habitat availability has been maximized.

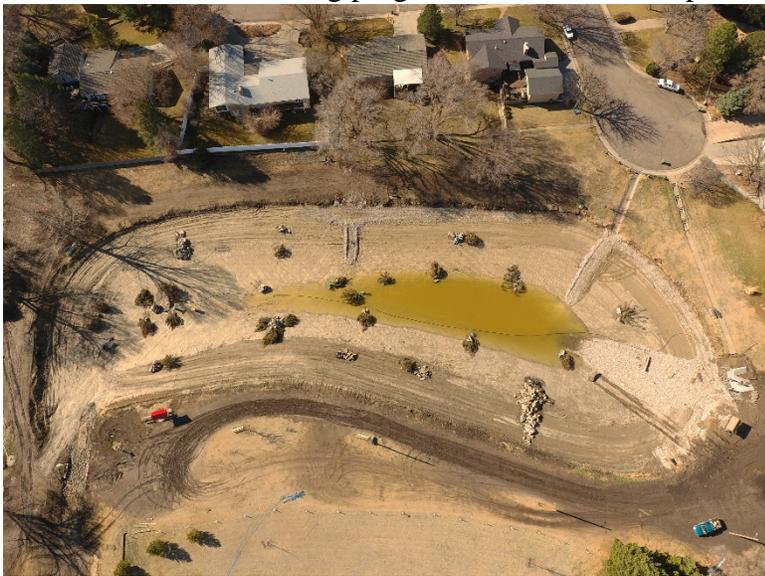
Aerial view of fish habitat distribution at Villa High
